Protecting the Common Waters of the Great Lakes Basin Through Public Trust Solutions

RE: SUPPLEMENTAL PUBLIC COMMENTS AND TECHNICAL NOTE ON THE JOINT APPLICATION OF ENBRIDGE ENERGY TO OCCUPY GREAT LAKES BOTTOMLANDS FOR ANCHORING SUPPORTS TO TRANSPORT CRUDE OIL IN LINE 5 PIPELINES IN THE STRAITS OF MACKINAC AND LAKE MICHIGAN [NO. 2HB-VGKO-35JE]

## Technical Note

## <u>Regarding Enbridge Line 5 Non-Compliance with 1953 Easement Requirements</u> <u>A Mechanistic Analysis of Straits Pipeline Washout Phenomena</u>

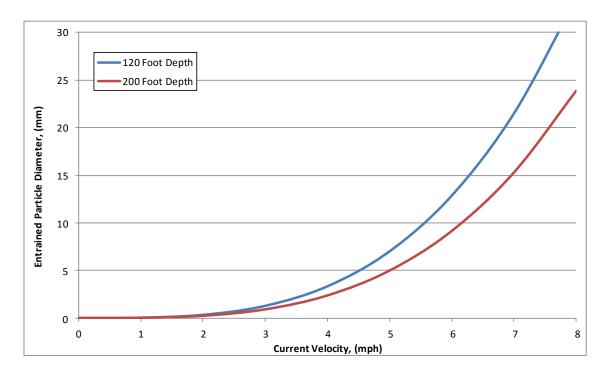
Although much has been published about the problem with washouts under Line 5 with resultant lack of support and easement violations, it does not appear that the mechanism causing this problem has been previously elucidated. Washouts occur because of currents that are fast enough to entrain soil particles and move them away from beneath the pipe. Figure 1, calculated from the Levillain<sup>3</sup> equation, illustrates the extremely nonlinear nature of the soil entrainment process. This figure shows that at currents below the design maximum of 2.26 mph no soil particles larger than 0.5mm can be entrained. This velocity is sufficient to entrain silt and small sand particles but is not capable of moving most soil particles. Because the Levillain equation is highly nonlinear, current speeds greater than this value have a disproportional impact on the size of soil particles that can be entrained and transported. A three mph current will entrain particles with diameters on the scale of a millimeter which includes typical lake bottom sand and a six mph current can transport small rocks with diameters on the order of one half inch. This knowledge leads to the conclusion that pipeline washouts occur during events that cause extreme currents which are most likely found in turbulent eddy flows resulting from exceptional weather events across the Great Lakes Basin.

Figure 1. Soil Particle Entrainment Velocity as a Function of Underwater Current Velocity
