Zebra and Quagga Mussels and their Impact on Bare Steel

Gary Street, M.S., P.E. October 27, 2017

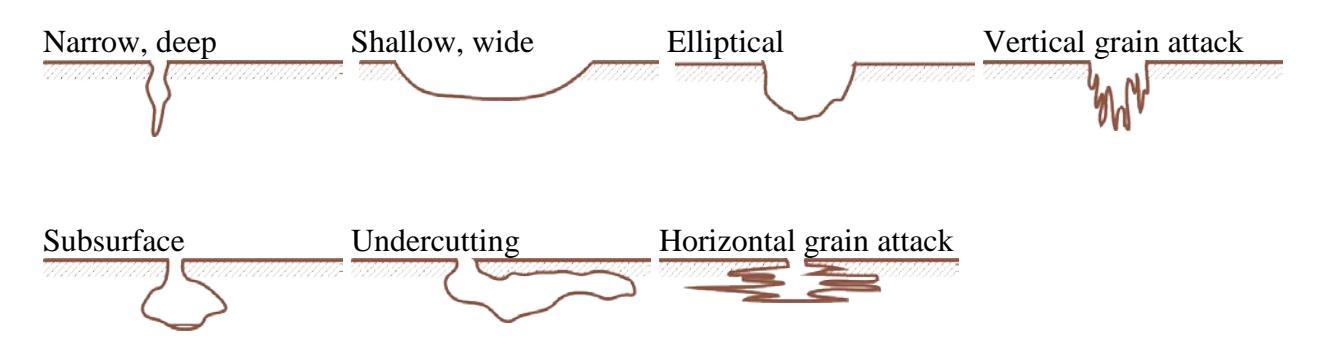
Typical examples of pitting corrosion are shown below:¹⁴

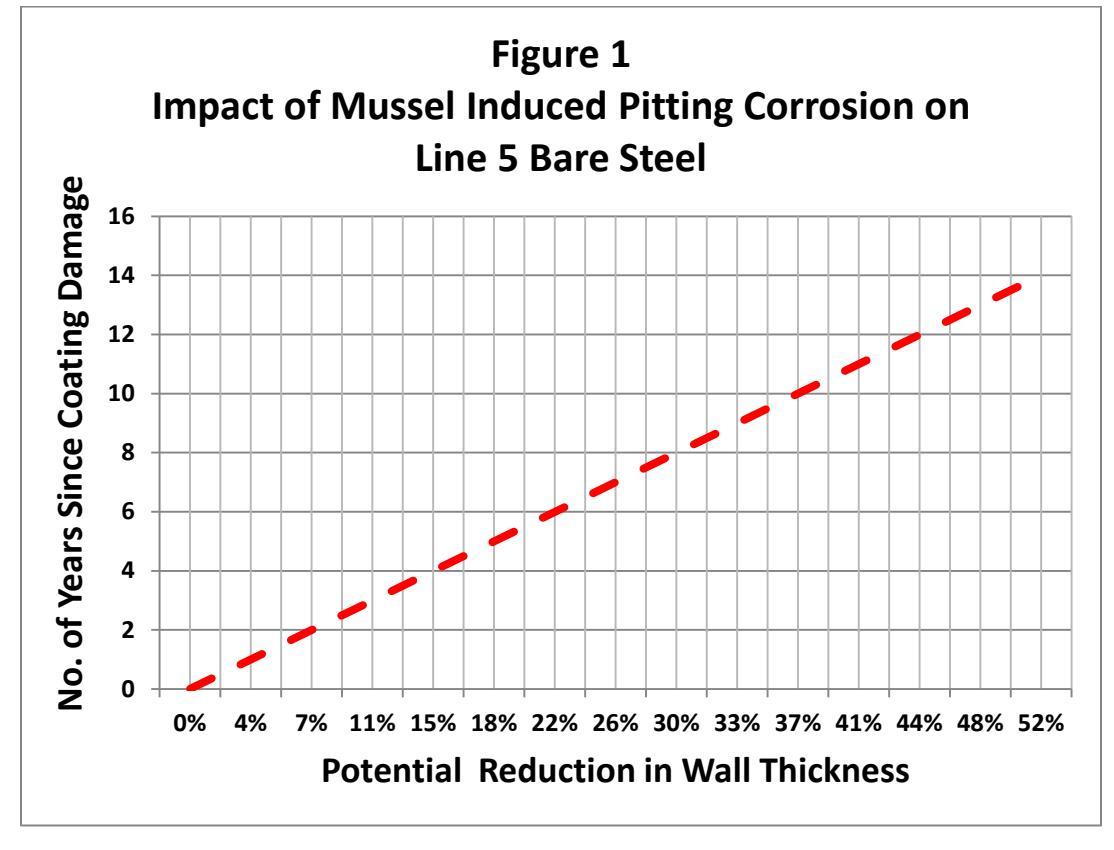
30 mpy = 30/1000 inches per year = 0.03 inches per year For 14 years, this amounts 0.03*14 = 0.42 inches of pitting corrosion.

Probable wall thickness in 2017 due to pitting corrosion since 2003 = (0.812-0.42) = 0.392 inches.

To say it another way, where pitting corrosion due to the impact of zebra mussels on bare steel has occurred, the wall of the pipeline <u>may be</u> only 48% as thick as it was in 1953 when it was originally installed.

Figures 1 & 2 portray the impact of corrosion on bare steel caused by mussels.

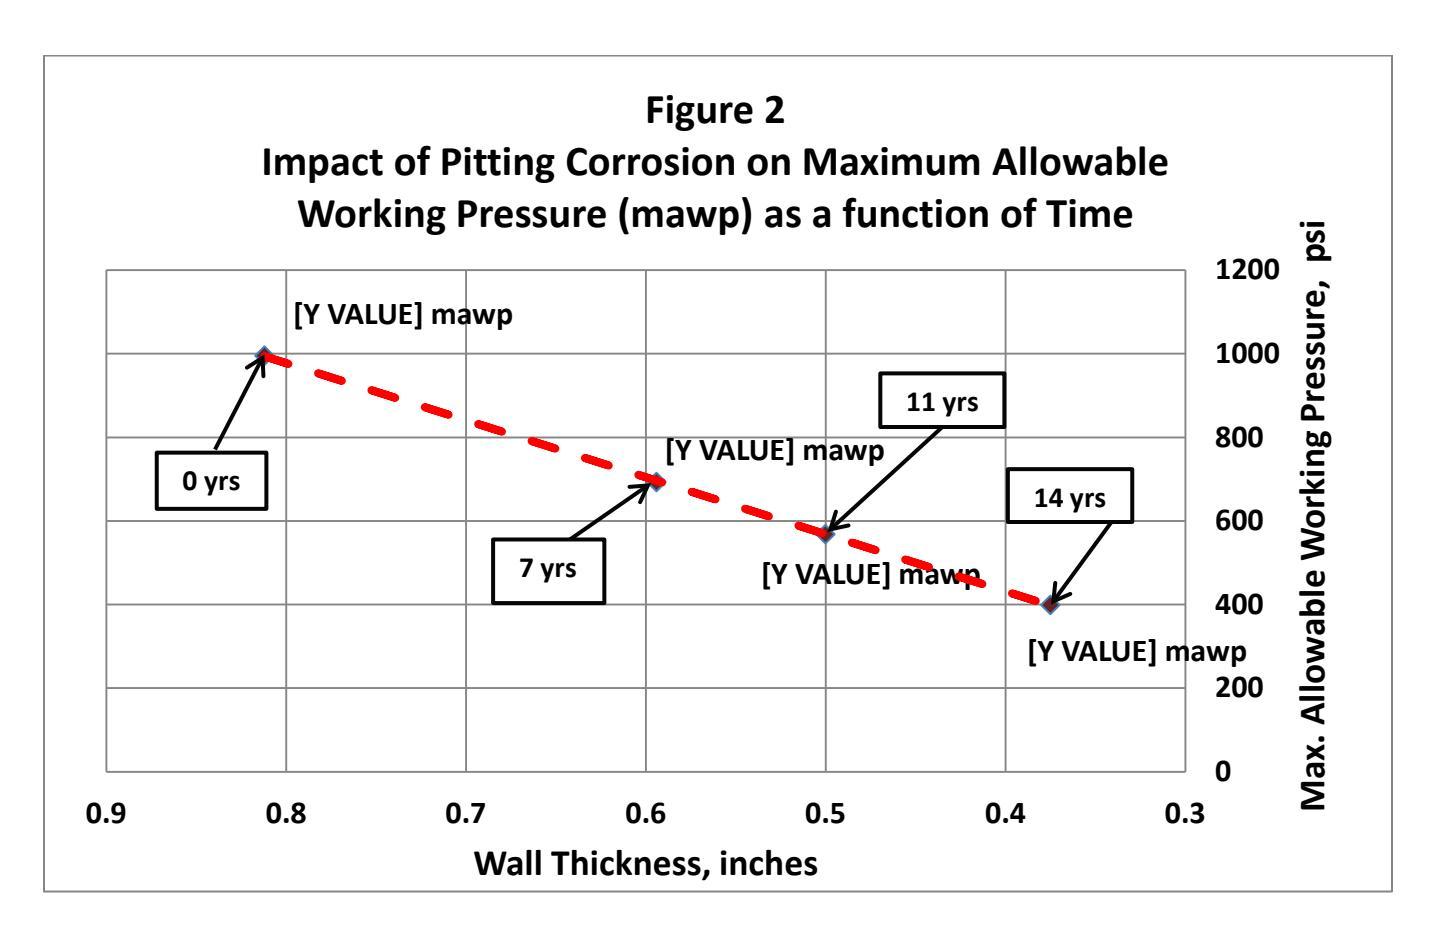
Figure 2 is a plot of Maximum Allowable Working Pressure (mawp) for schedule 60, 20 inch outside diameter, seamless carbon steel pipe.¹⁹ This is the pipe that was installed at the Straits of Mackinac in 1953.

For example, the chart tells us that in 7 years, pitting corrosion will cause the MAWP to decrease from 995 psi to 693 psi; in 14 years (the period of time from 2003 to 2017), the MAWP can decrease to 399 psi.

Figure 2 assumes that pitting corrosion did not occur prior to 2003. Enbridge has recently admitted that damage has occurred to the pipeline coating while the new supports were being installed.²⁰ They apparently have been aware of this since 2014, but only recently acknowledged it. While Enbridge claims to have discovered the damage in 2014, we do not know when it actually occurred, so have assumed that at least some of the damage to the coating took place in 2003.
